Honduras Bridge

Final Report

Prepared by:
William Hellman
Caroline Janssen
Miranda Mangahas
Nathan Miller
Cole Siegenfeld

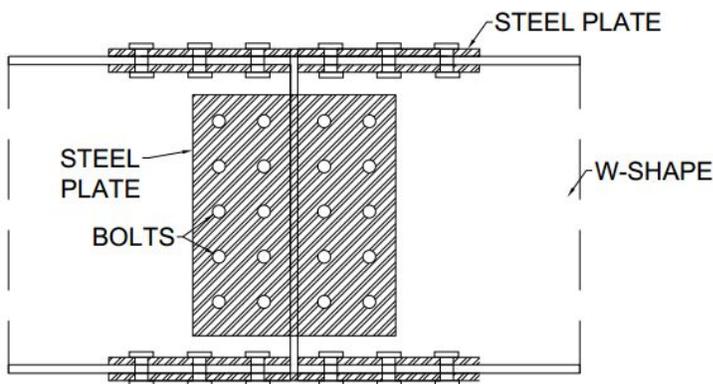
Figure 1: Splice Elevation View

Since each beam will be divided into three sections, it was necessary to design beam splice connections. The connections consisted of bolted plates on the top and bottom flanges and on the webs of the W-shape steel members. Using 3 beams of equal length, the splices would occur at the third points of the span. Using an Excel Spreadsheet from the *American Institute of Steel Construction* (AISC) in tandem with hand calculations for assurance, the specifications were input for the bridge. In return, the number of bolts needed for both the flange and web splice plates were given. In this case, the flanges required two rows of 3 bolts each and the webs required two rows of 5 bolts each. Conceptual drawings can be seen below in Figures 1 and 2:

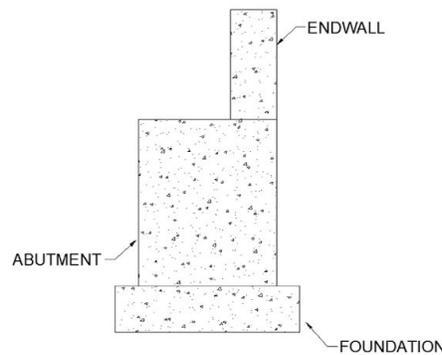
Figure 4: Bridge Foundation Design

The foundation design relies heavily on the information gathered in the geotechnical assessment. The maximum gross allowable bearing capacity of the soil is 2000 pounds per square foot. This value is potentially conservative, as every boring hit rock before the 6.5 feet specified by B2P, which qualifies the ground conditions as rock (*Bridges to Prosperity*). However, the cause of refusal could also be large boulders suspended throughout the subsurface profile, so the conservative value was used. The foundations are constructed of three elements, as seen in Figure 4: a footing (foundation), an abutment, and an endwall.

The footing must be large enough to spread the weight of the bridge-foundation-combo over the soil, so as not to exceed 2000 pounds per square foot. The abutment raises the bridge elevation so that it is above the maximum water level determined in the hydrological assessment, and the endwall acts as a retaining wall to hold backfill material from under the ramps. The foundation will be made of concrete, and will need enough rebar for possible tension forces in the concrete.

The bridge is relatively light compared to the weight of large buildings that foundations often need to support. The calculations for the dimensions/thickness of the concrete and the area of steel were both calculated, as can be found in Appendix E.4. However, the calculated values were all below the minimum required footing thickness and area of steel, so the minimum specifications were utilized for the design. This resulted in a 1 foot thick footing, 5.3/5.8 foot tall abutments, and 458 feet of rebar.

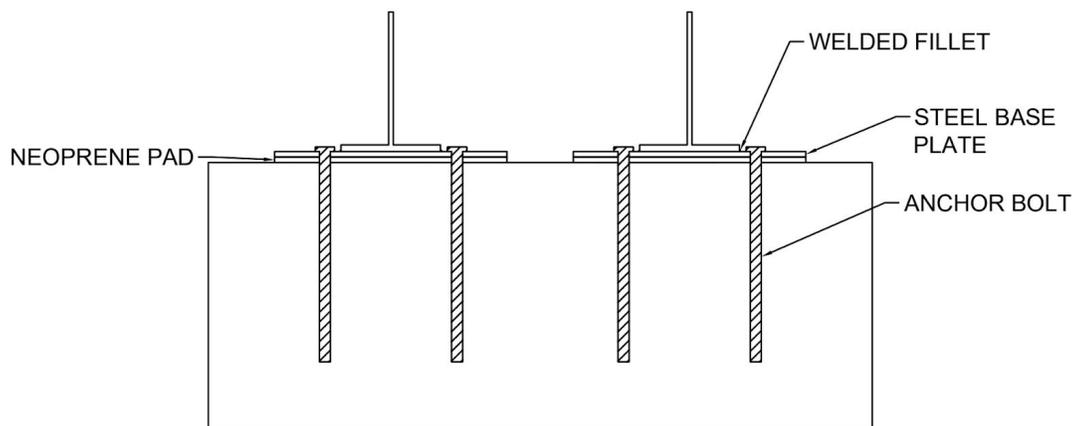
Figure 5: Beam-to-abutment connection geometry.

Due to the variation in temperature, slotted holes on one side of the bridge was deemed necessary. The connections between the beams and abutments on the north end will be bolted in place while the south end will have slotted holes to allow for thermal expansion and contraction. Using AASHTO's Pedestrian Bridge Guidelines, the thermal expansion was estimated to be around 0.76 inches. To allow for this expansion, the slotted holes are designed to be 2.5 inches long with a 1.125 inch width to accommodate the 1 inch anchor bolt. The 2.5 inch slot size allows for an expansion or contraction of 1.25 inches, allowing for a large clearance of our estimated expansion length.

To connect the W24x68 beams to the abutment, a bearing plate, a neoprene pad, and anchor bolts are utilized, as visualized in Figure 5. The beams are attached with a fillet weld to the bearing plate, which lays on top of the neoprene pad. The base plates on the south end of the bridge will have the aforementioned slot hole to allow for thermal expansion and contraction. The neoprene pad, however, will not have a slotted hole and will remain stationary.

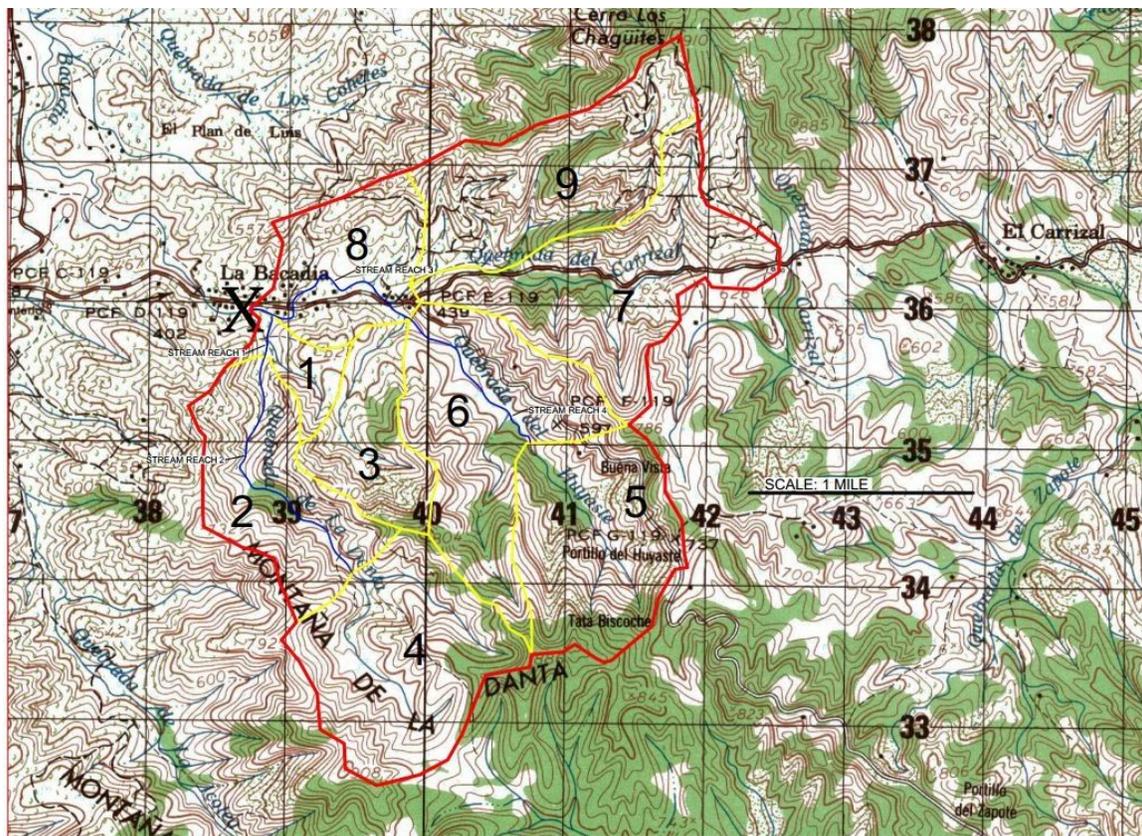
Figure 1: Watershed and Subbasin Overview

The watershed boundary was delineated by hand using a topographical map (attached). The watershed boundary was then drawn onto the topographical map in AutoCAD Civil 3D, then delineated into 9 separate subbasins. There are four stream reaches in the watershed located in subbasin 1, subbasin 2, subbasin 6, and subbasin 8. The delineations are outlined in Figure 1 below. The X is the approximate location of the bridge site.

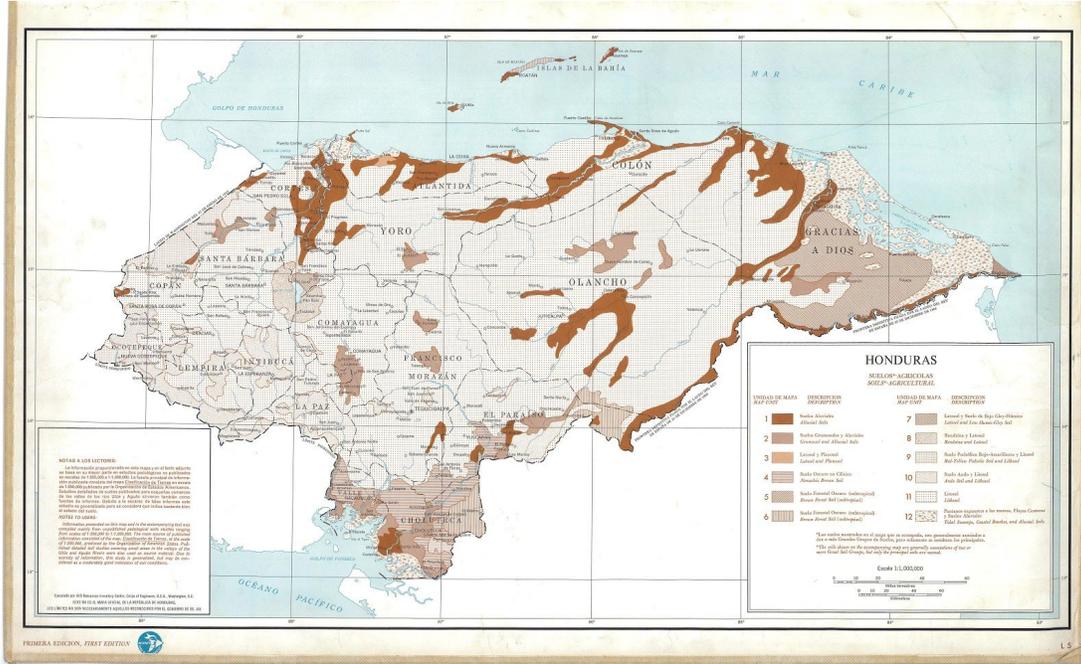
Figure 2: Honduras Soils Map

The SCS Curve Number Loss Method was used to estimate runoff. A curve number for each subbasin had to be estimated. The curve number relates the land use to infiltration rates. Based on the soil map in Figure 2, the predominant soil surrounding our area of interest were alluvial soils. We used both this map and our observations from the auger samples to determine the soil to be class D. We assumed a wet antecedent moisture Based on these properties and the

land use we estimated the curve number to fall between 65-90. Using google maps, we estimated the impervious areas for each subbasin.

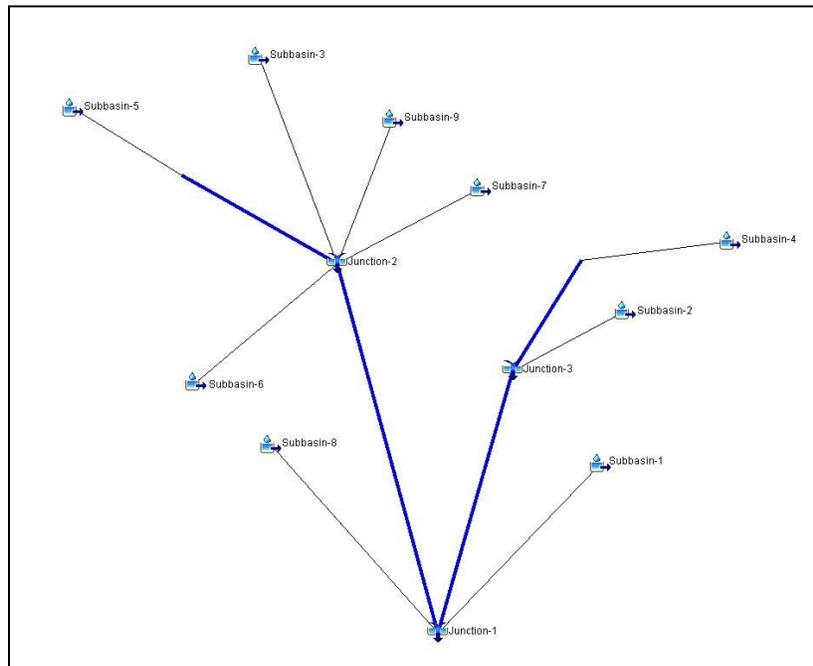
Figure 3. HEC-HMS Basin Model

HEC-HMS is the computer system used to analyze the watershed. The data outlined in Appendix A was inputted into the model. The basin model for Bacadillas is seen in *Figure 3*. The precipitation data used for this analysis was from a 72-hour storm from Hurricane Mitch. This storm was estimated to be a 1 in 500/600 year storm event.

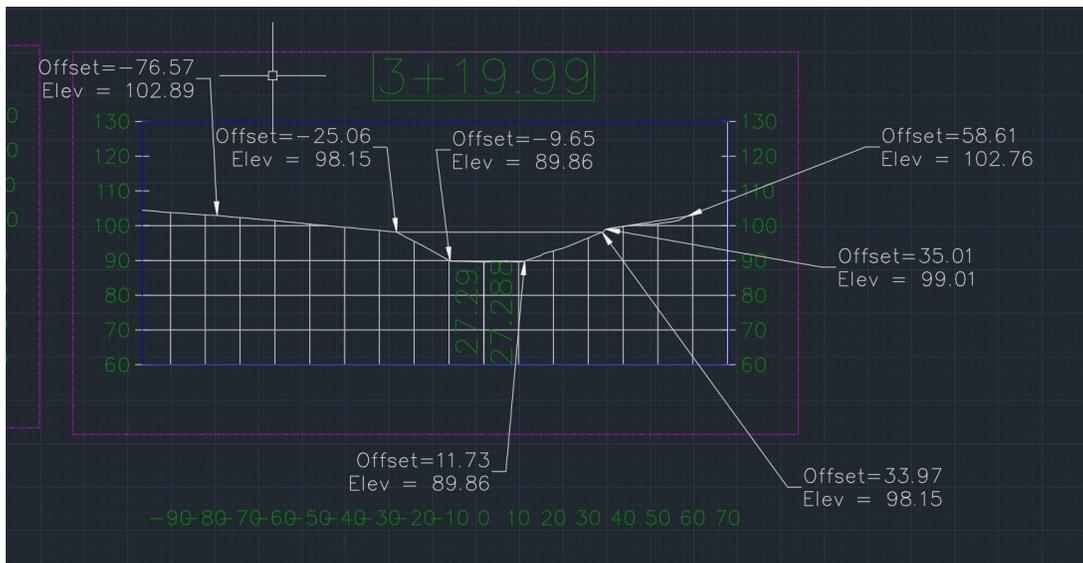
Figure 4: Stream Crossing at Proposed Bridge Location

After inputting all necessary information, the model computed the maximum flow downstream at Junction 1. This flow was then used to compute the maximum water height using Manning's equation for open channel flow based on an estimated cross section seen in Figure 4.

A roughness coefficient (n) of 0.15 was estimated for the stream channel based on the high amount of trees, shrubs, rocks, etc. found in the stream.

Based on our model, the maximum flood height using the most conservative curve number estimate is approximately 10-ft. The measured high water marks are about 11-ft above the bottom of the river. Therefore we recommend the lowest point of the bridge should be 11 feet above the centerline of the stream, which is an elevation of 101.4' at the proposed bridge site. This elevation corresponds to the elevation of the back porch of one of the community member's

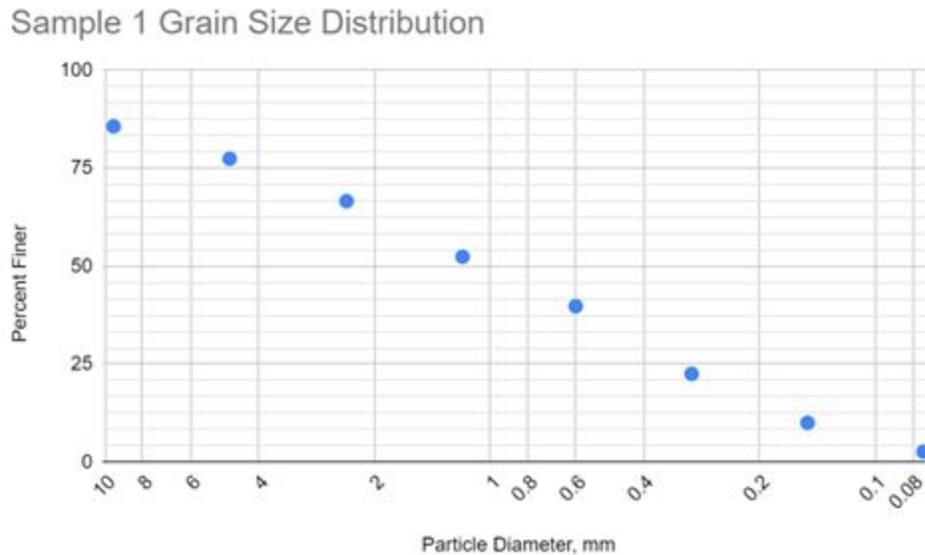
Figure 2: Soil Sample 1 Grain Size Distribution

Mass of dry sample: (g)	655.88				
Sieve no.	Diam. (mm)	Mass Retained	% Retained	% Retained Cumulative	% Passing
3/8	9.5	93.8	14.3013966	14.3013966	85.6986034
4	4.75	54.24	8.269805452	22.57120205	77.42879795
8	2.36	70.88	10.80685491	33.37805696	66.62194304
16	1.18	93.16	14.20381777	47.58187473	52.41812527
30	0.6	82.81	12.6257852	60.20765994	39.79234006
50	0.3	113.24	17.26535342	77.47301336	22.52698664
100	0.15	81.95	12.49466366	89.96767701	10.03232299
200	0.075	48.45	7.387022016	97.35469903	2.64530097
Pan		16.25	2.477587364	99.83228639

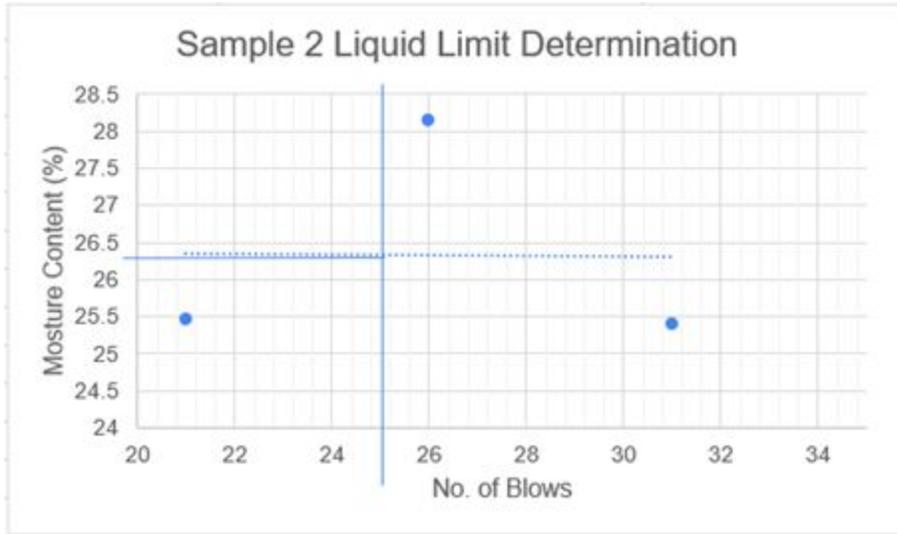
Figure 6: Soil Sample 2 Liquid Limit Determination

Can no.	Mass of Wet Soil + Can (g)	Mass of Dry Soil + Can (g)	Mass of Can (g)	Mass of Dry Soil (g)	Mass of Moisture (g)	Water Content (%)	No. of Blows
65	43.59	40.49	28.31	12.18	3.1	25.45155993	21
79	36.33	34.58	28.36	6.22	1.75	28.13504823	25
71	39.05	36.85	28.19	8.66	2.2	25.40415704	31
Can no.	Mass of Wet Soil + Can (g)	Mass of Dry Soil + Can (g)	Mass of Can (g)	Mass of Dry Soil (g)	Mass of Moisture (g)	Water Content (%)	
96	38.06	36.16	28.18	7.98	1.9	23.80952381	
69	36.33	34.78	28.2	6.58	1.55	23.556231	
Liquid Limit:	26.25						
Plastic Limit:	23.68287741						
Plasticity Index:	2.56712294

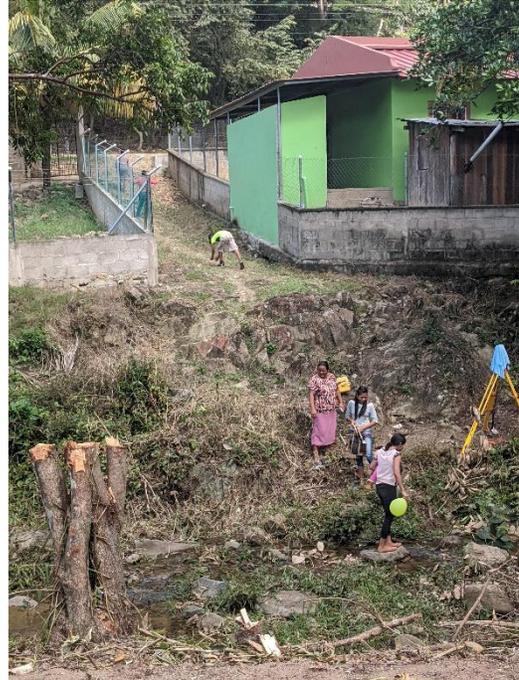
Figure 4: Community members crossing the river

Outside of the structured meetings, the design team also had many casual interactions with the community. The temporary bridge installed by Louisa had worn out for the year, so residents were navigating the riverbed to cross the river. The sides were often steep and unstable, visible in Figure 4, and older residents were helped across by other members of the community. It was already precarious during the dry season, putting into perspective how dangerous it could become during the wet season.

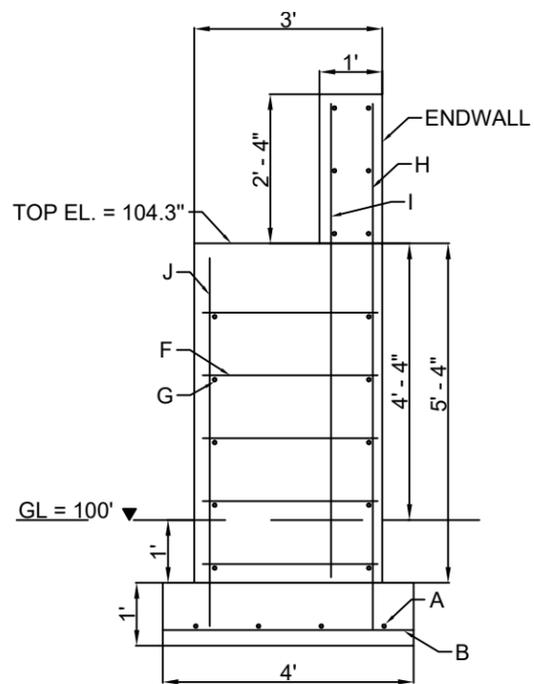
**ELEVATION:
NORTH FOUNDATION,
ABUTMENT, ENDWALL**

BILL OF MATERIALS				
NAME	BAR SIZE	LENGTH	QUANTITY	TOTAL LENGTH
A	#6	66"	8	528"
B	#6	42"	12	504"
C	#6	104"	5	520"
D	#6	92"	5	460"
E	#6	76"	5	380"
F	#6	30"	14	420"
G	#6	54"	26	1404"
H	#6	98"	5	490"
I	#6	86"	5	430"
J	#6	70"	5	350"
			TOTAL	458 FT
CONCRETE				239 CF

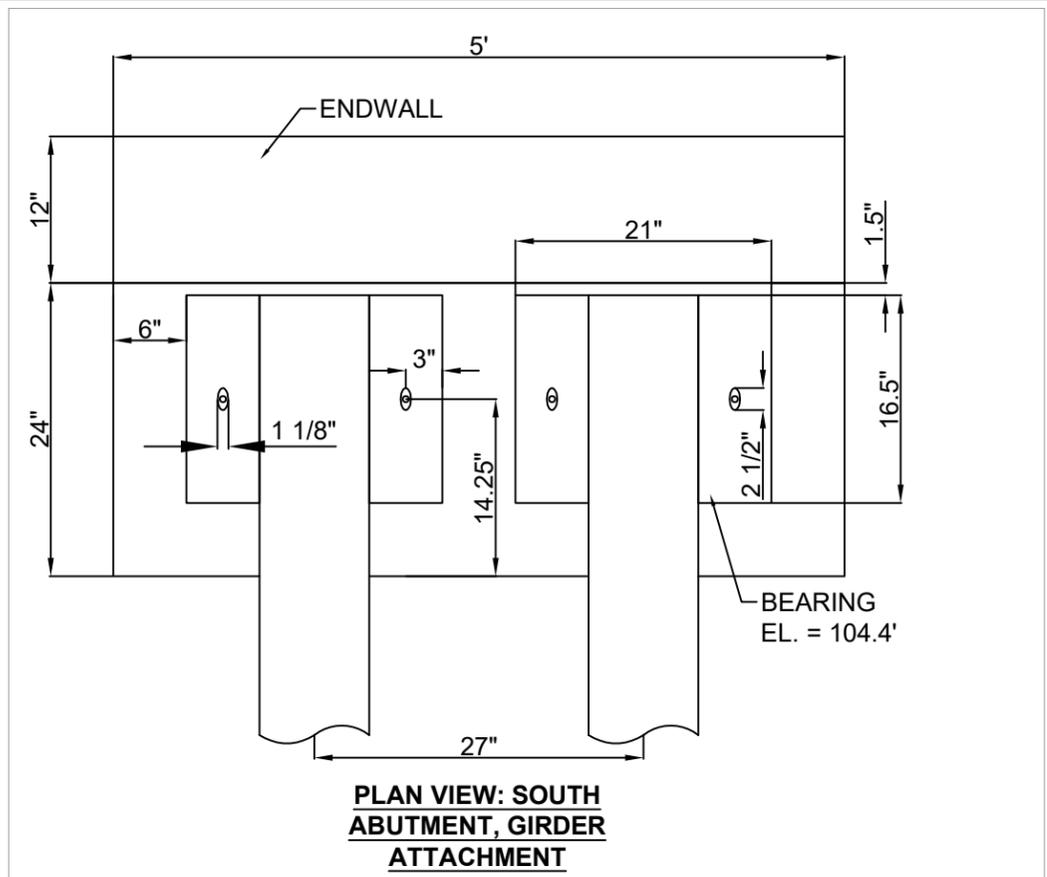
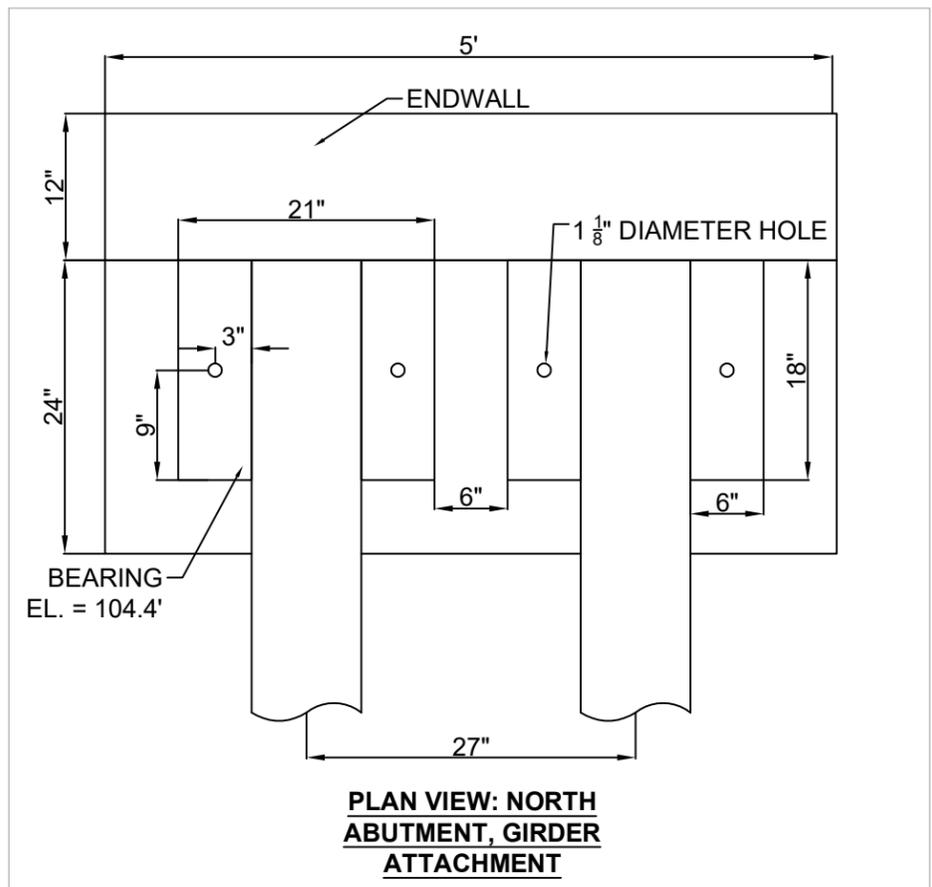
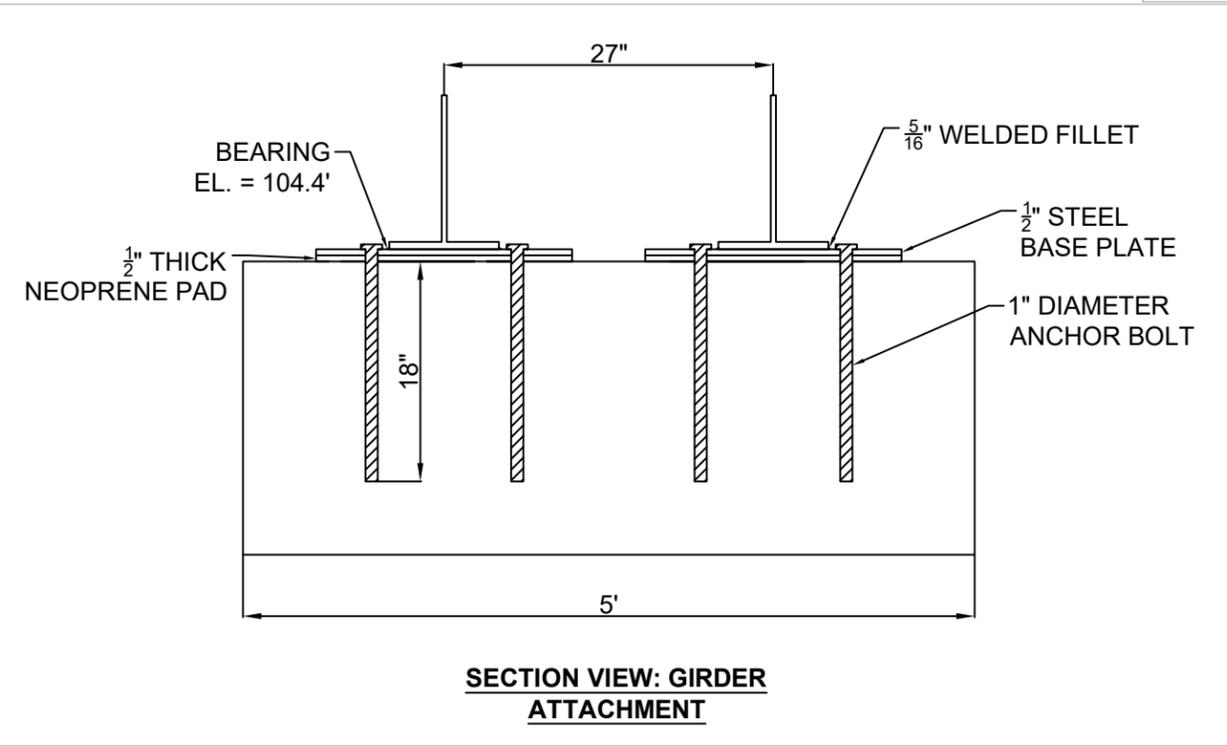
LAS BACADILLAS
STRINGER BRIDGE
FOUNDATION DETAILS

1. ANCHORS CAN BE DRILLED AND GROUTED.
2. BASE PLATE ON SOUTH END TO HAVE SLOTTED EXPANSION HOLE AS SHOWN. NEOPRENE PAD SHALL NOT BE SLOTTED.

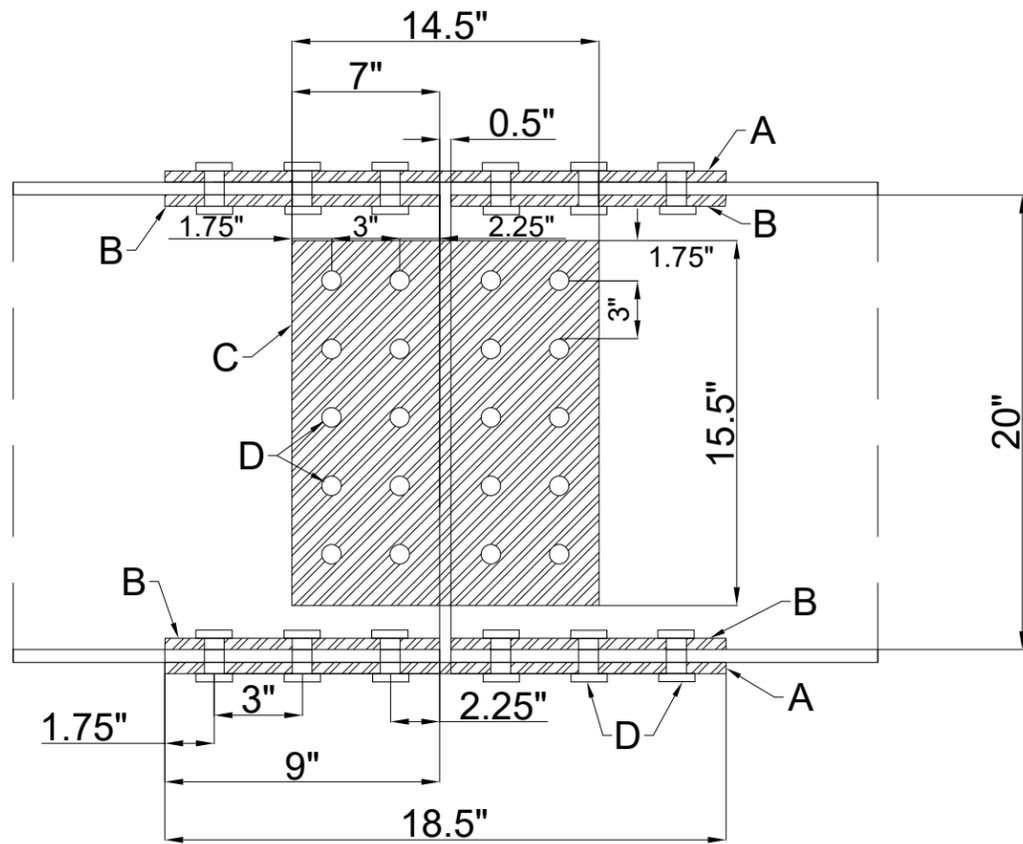
**SPLICE
ELEVATION VIEW**

1. SPLICE BEAMS AT THIRD POINTS OF BRIDGE, EVERY 28'
2. THERE SHALL BE 2 ROWS OF 3 BOLTS EACH FOR EACH FLANGE SPLICE.
3. THERE SHALL BE 2 ROWS OF 5 BOLTS EACH FOR EACH WEB SPLICE.
4. ALL BOLTS SHALL BE $\frac{7}{8}$ " DIAMETER A325 BOLTS.
5. ALL PLATES SHALL BE $\frac{1}{2}$ " THICK GRADE 50 STEEL.
6. ALL STEEL SHALL BE WEATHERING STEEL IF AVAILABLE. OTHERWISE PRIME AND PAINT TO PREVENT CORROSION.
7. STIFFENER PLATES TO BE WELDED TO W-SHAPE.
