Honduras Pedestrian Bridge

William Hellman, Caroline Janssen, Miranda Mangahas, Nathan Miller, and Cole Siegenfeld

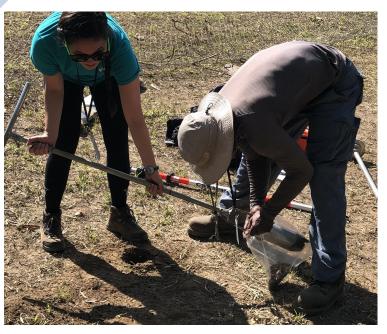
Auger Testing

4 Boring Samples

- 3 on clinic side
- 1 on road side

Boring	Auger Refusal Depth (ft)
B-1	2.00
B-2	4.00
B-3	1.83
B-4	1.00
